North American Performance Validation

For  
**AESTHETICS**  
and  
**DURABILITY**  
the choice for buildings is  
**PREPAINTED**  
**55% Al-Zn**  
**COATED STEEL**

**THE MAGIC FORMULA**  
**FOR METAL BUILDINGS**

This report covers surveys of established metal buildings utilizing both prepainted 55% Al-Zn coated, and prepainted hot-dip galvanized, steels in the most aggressive acid rain zones of North America.

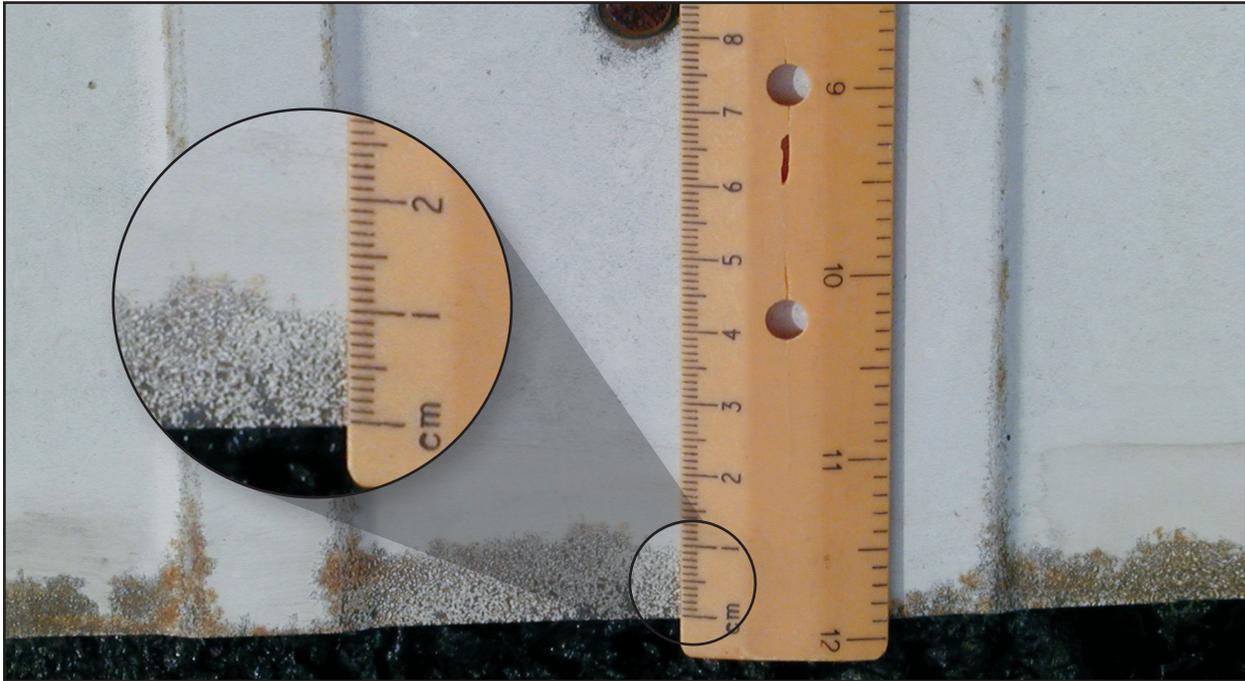
**At the drip edge, the increased time of wetness produces the most aggressive corrosion — 55% Al-Zn coatings enhance the long term durability of prepainted steels**

**Drip edge of a prepainted GALVALUME roof on a 20-year old building in an acid rain environment, Pennsylvania, U.S.A.**

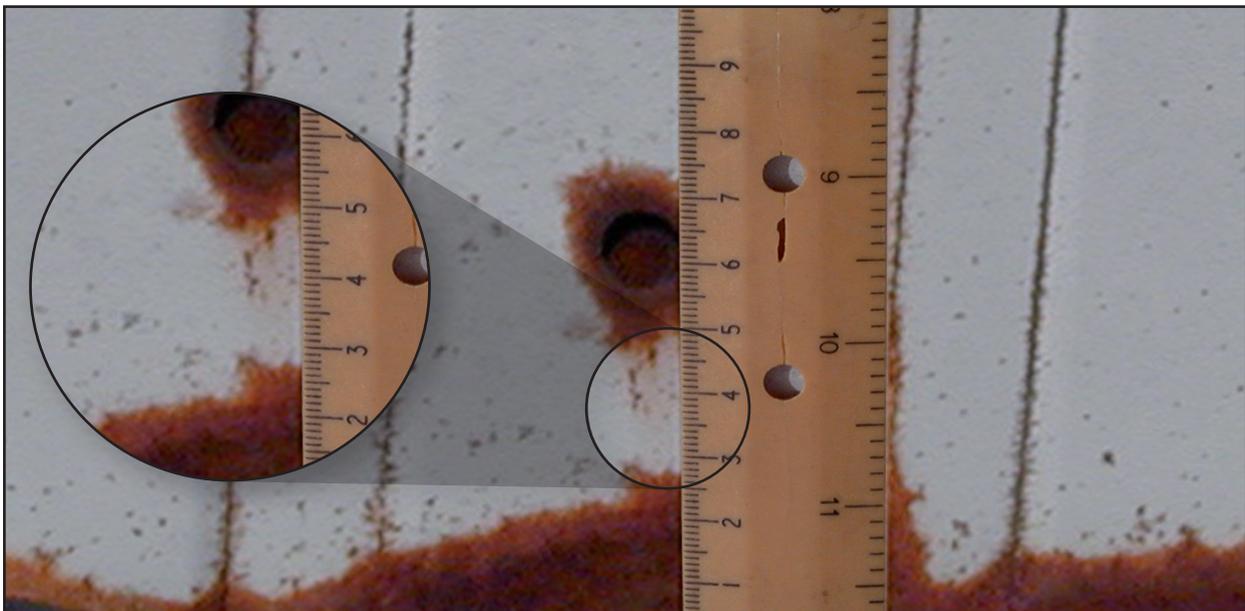
**Drip edge of a prepainted galvanized steel roof on a 21-year old building in an acid rain environment, Pennsylvania, U.S.A.**

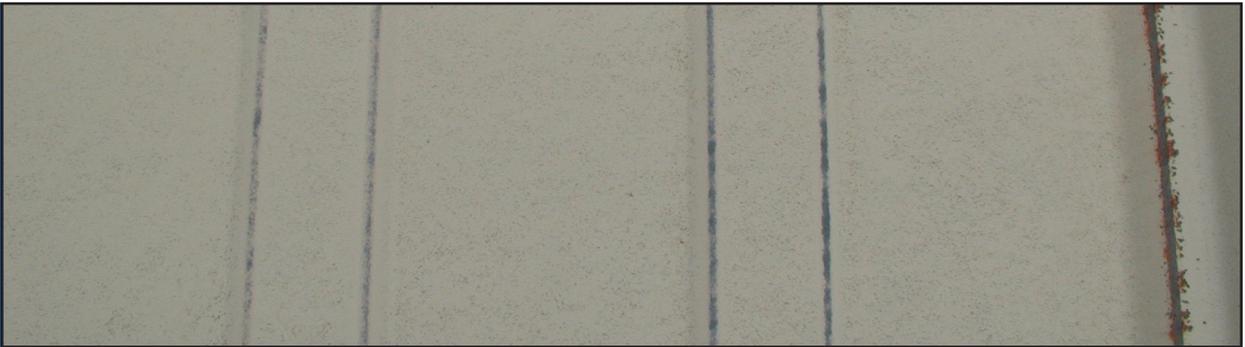
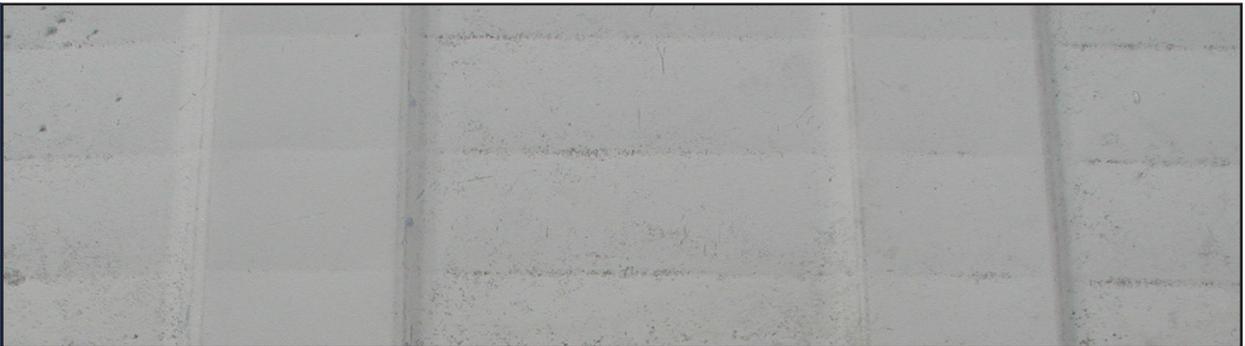
PREPAINTED  
HOT-DIP GALVANIZED

PREPAINTED  
55% AL-ZN COATING

Corrosion performance at buildings in rural/acid rain Ontario: hot-dip galvanized after 21 years; 55%Al-Zn coating after 17.5 years.

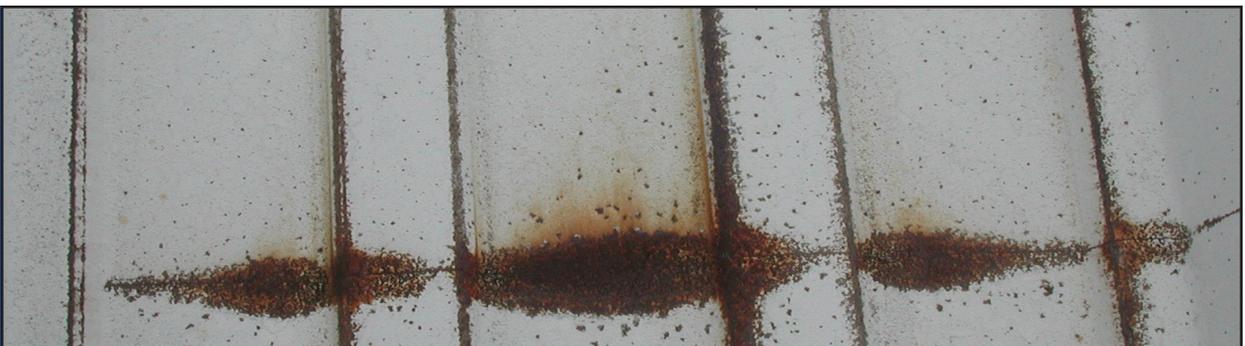
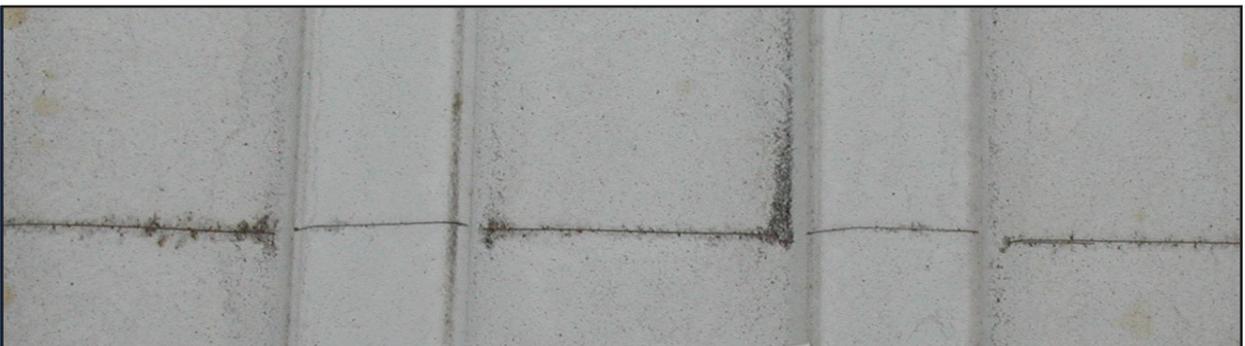
PREPAINTED  
HOT-DIP GALVANIZED

PREPAINTED  
55% AL-ZN COATING

Corrosion performance at a manufactured defect (scribe) on buildings in heavy industrial Ontario after 20 years exposure.

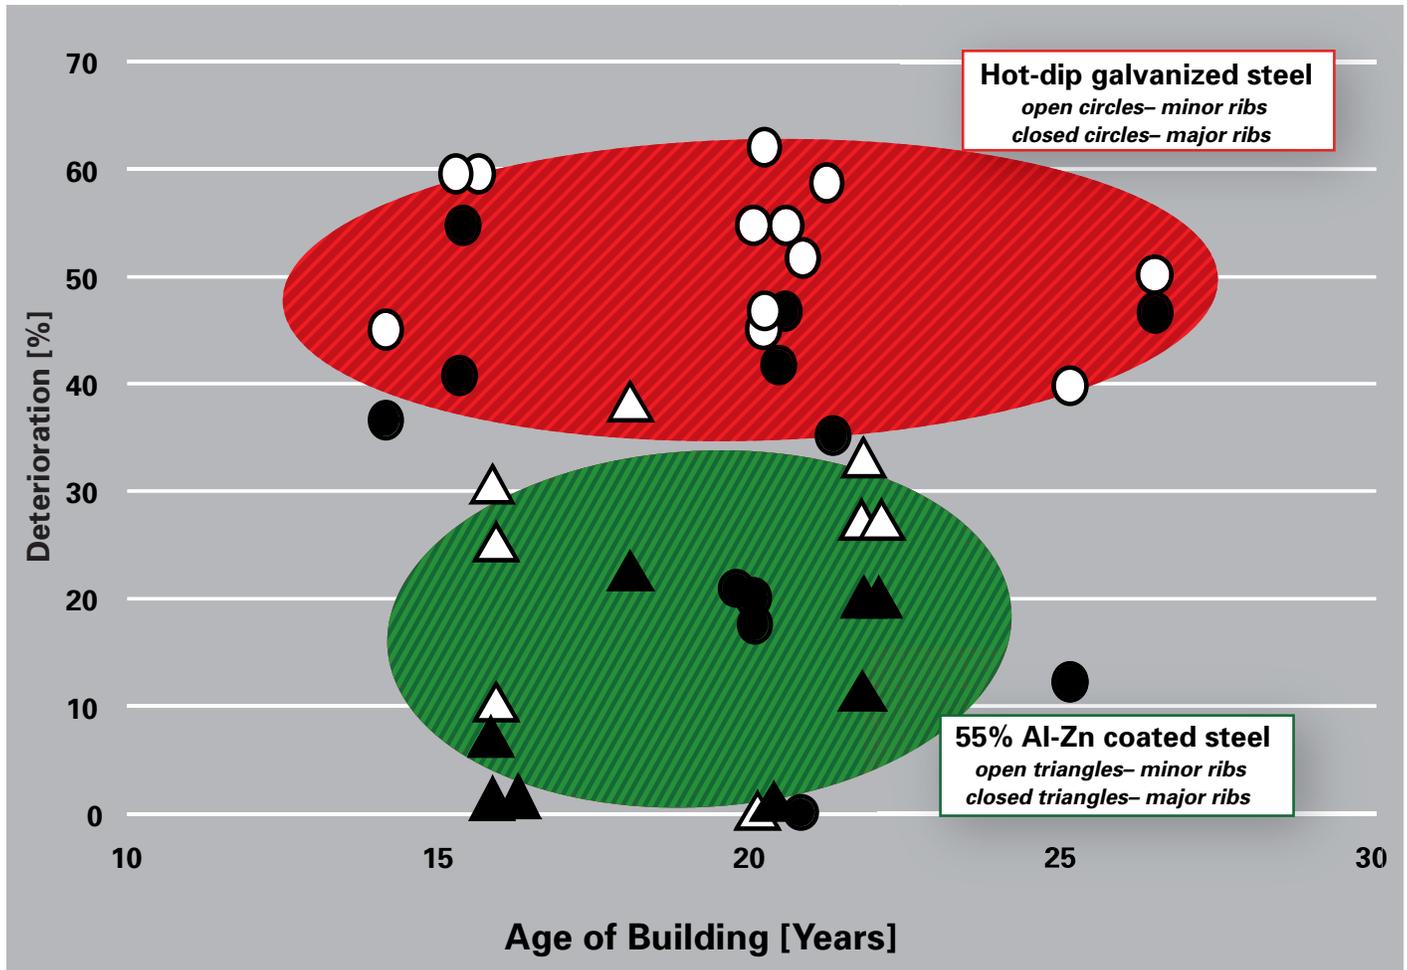
Long-term evaluations confirm that 55% Al-Zn coated steels outperform hot-dip galvanized at panel bends. At the more heavily-strained minor ribs, the performance differences are even more evident with the hot-dip galvanized performance deteriorating more than twice as fast as 55% Al-Zn coatings after 15 to 20 years exposure.

During roll forming, the major ribs are formed first and serve as locking points for the subsequent forming that produces the minor ribs. The minor bends are therefore more highly strained and can cause the paint and the metallic coatings to crack. When the zinc's galvanic protection has been depleted, the prepainted hot-dip galvanized steel begins to quickly corrode and the appearance of red rust at the bends indicates the corrosion protection from the zinc has been exhausted. In contrast, the corrosion products of the coating of 55% Al-Zn inhibit further corrosion and extend the useful life of the building.
